HOME DEFECT INSPECTION REPORT  
(SAMPLE)

AUGUST 13, 2019

Newly House

Terrace

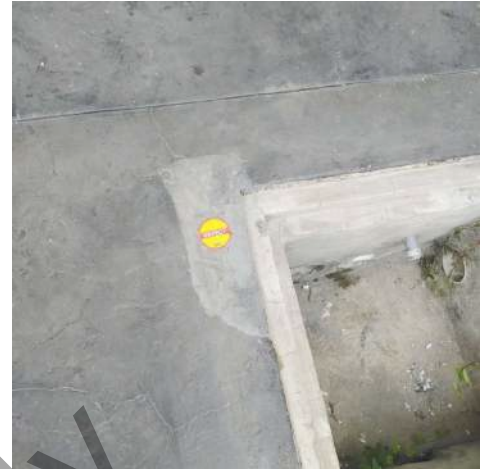
#### 4.1.1 Floors

Flooring had severe surface areas of staining or discoloration. Recommend a qualified flooring contractor evaluate & remedy.

- Stains mark

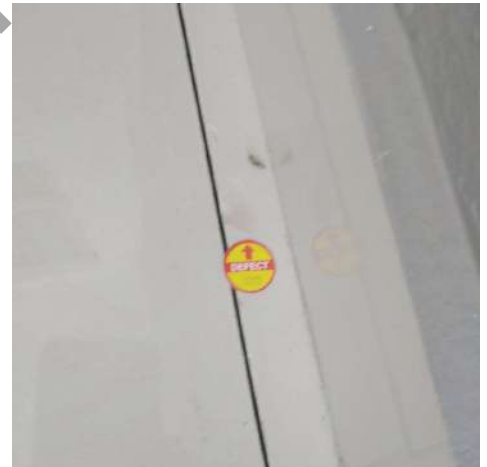
#### 4.1.2 Floors

Floors have severe surface damage visible at the time of the inspection. Recommend a qualified flooring contractor evaluate & remedy.

- Chipping

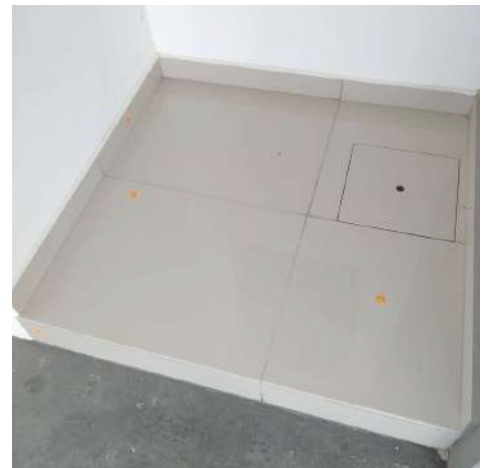
#### 4.1.3 Floors

Hollow tiles are present at time of inspection. Recommend a qualified contractor re-attach and seal.

- Hollow sound

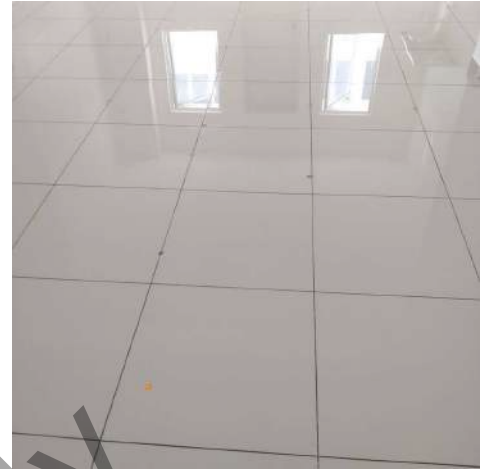
#### 5.1.1 Floors

Flooring had severe surface areas of staining or discoloration. Recommend a qualified flooring contractor evaluate & remedy.

- Stains
- Tonality

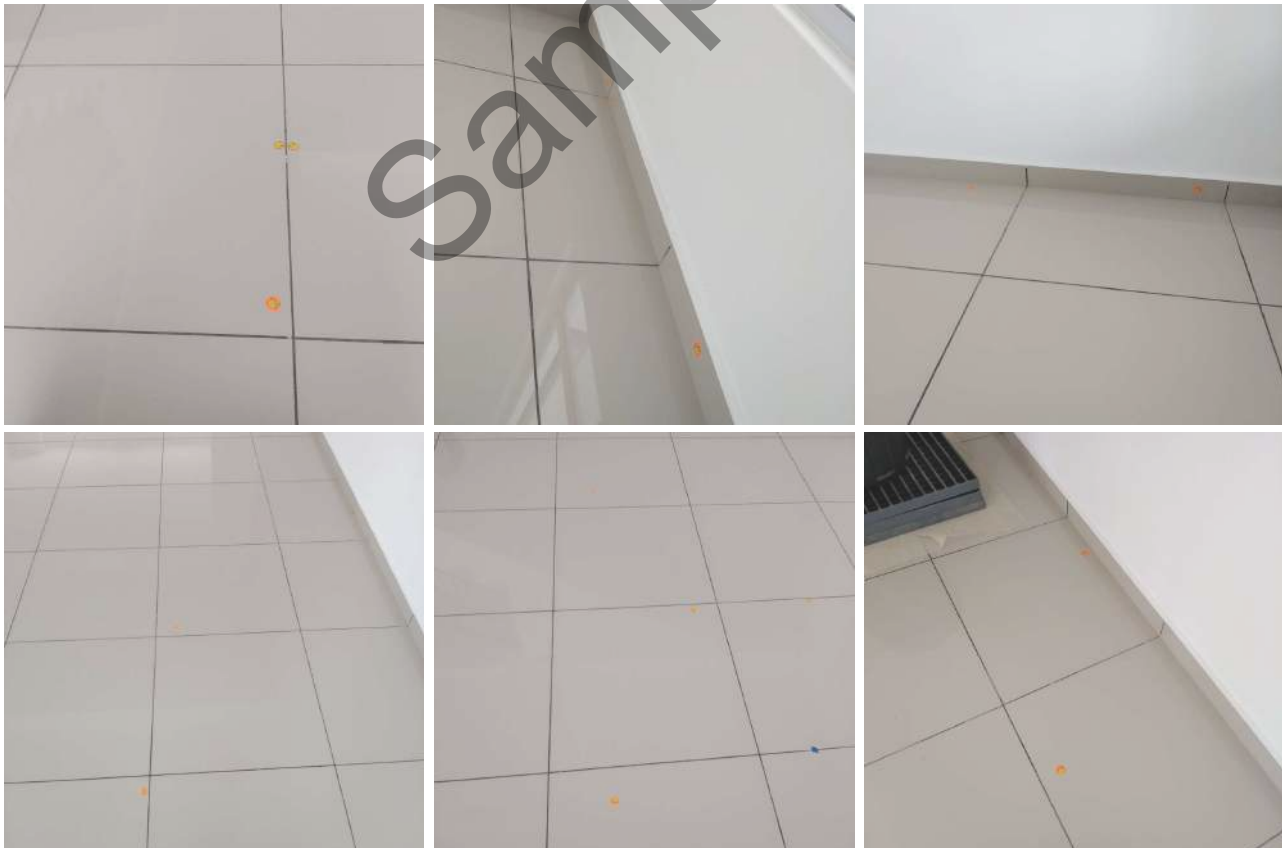
#### 5.1.2 Floors

Hollow tiles are present at time of inspection. Recommend a qualified contractor re-attach and seal.

- Hollow sound

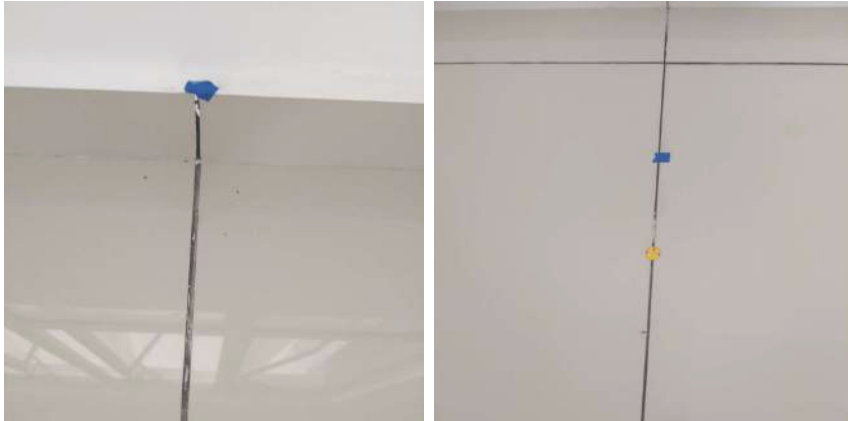
### 5.1.3 Floors

Uneven/Inconsistent grouting for the joints. Recommend a qualified contractor remove grout and regrout tile.

- Inconsistent joints

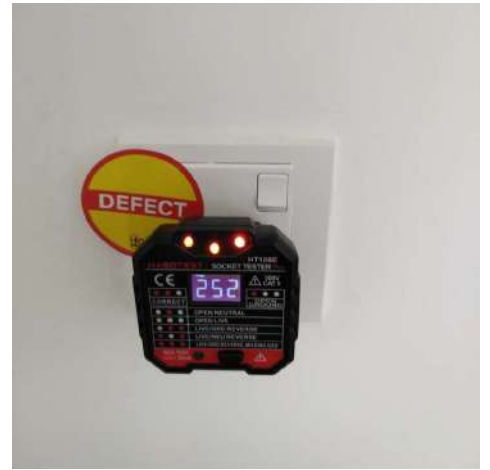
5.3.2 M&E Fittings

Malfunction for the socket switch, when it off the power still running.  
Recommend electrician check the wiring.

- Malfunction

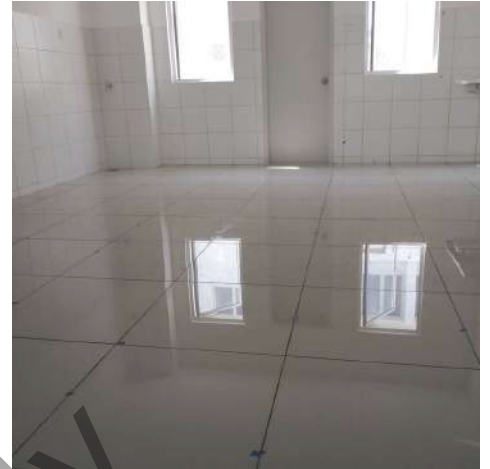
#### 6.1.1 Floors

Flooring had severe surface areas of staining or discoloration. Recommend a qualified flooring contractor evaluate & remedy.

- Stains
- Tonality

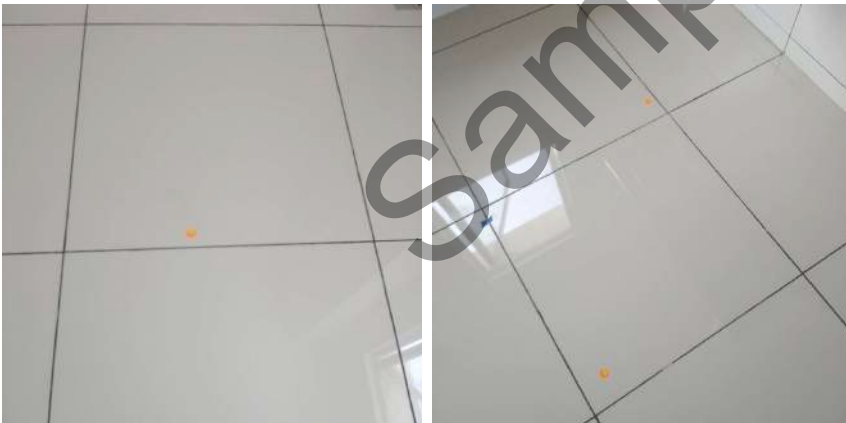
#### 6.1.2 Floors

Hollow tiles are present at time of inspection. Recommend a qualified contractor re-attach and seal.

- Hollow sound

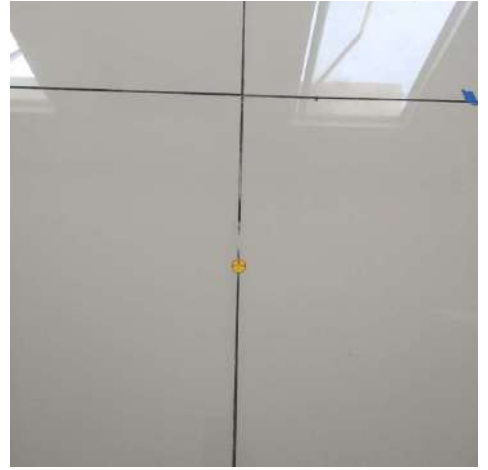
#### 6.1.3 Floors

Uneven/Inconsistent grouting for the joints. Recommend a qualified contractor remove grout and regrout tile.

- Inconsistent joints

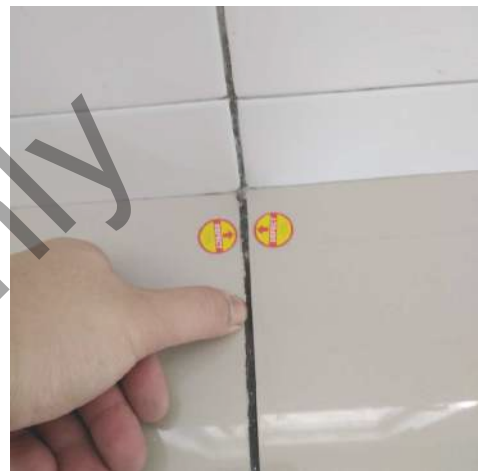
#### 6.1.4 Floors

Lippage tile found at the time of the inspection. Recommend a qualified contractor evaluate & remedy.

- Lippage tile

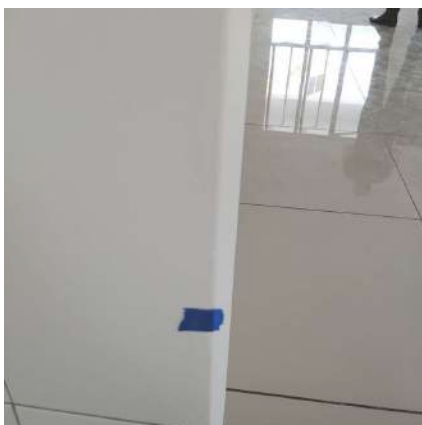
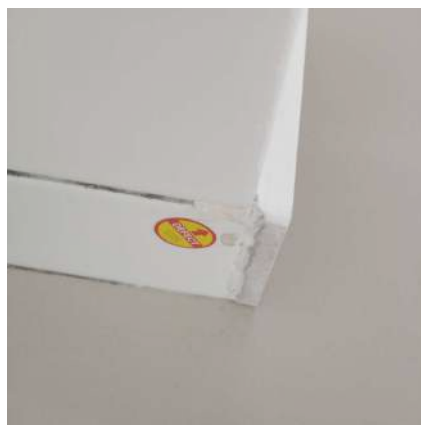
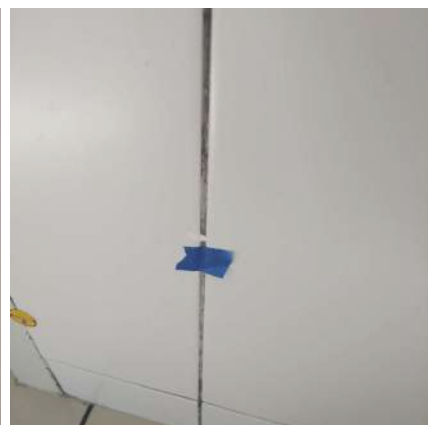
#### 6.2.1 Walls

Wall tile found staining or discoloration at the time of inspection. Recommend a qualified tiler contractor evaluate & remedy.

- Stains

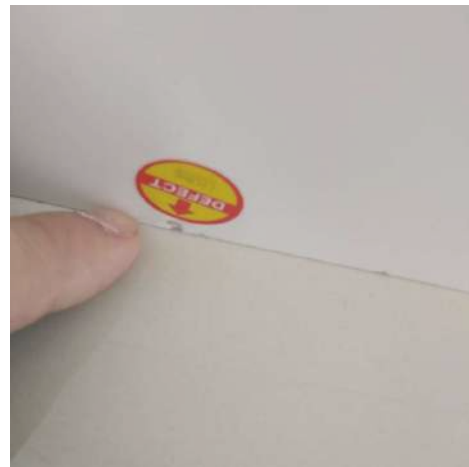
### 6.2.2 Walls

Wall tile have severe surface damage visible at the time of the inspection. Recommend a qualified contractor evaluate & remedy.

- Chipping

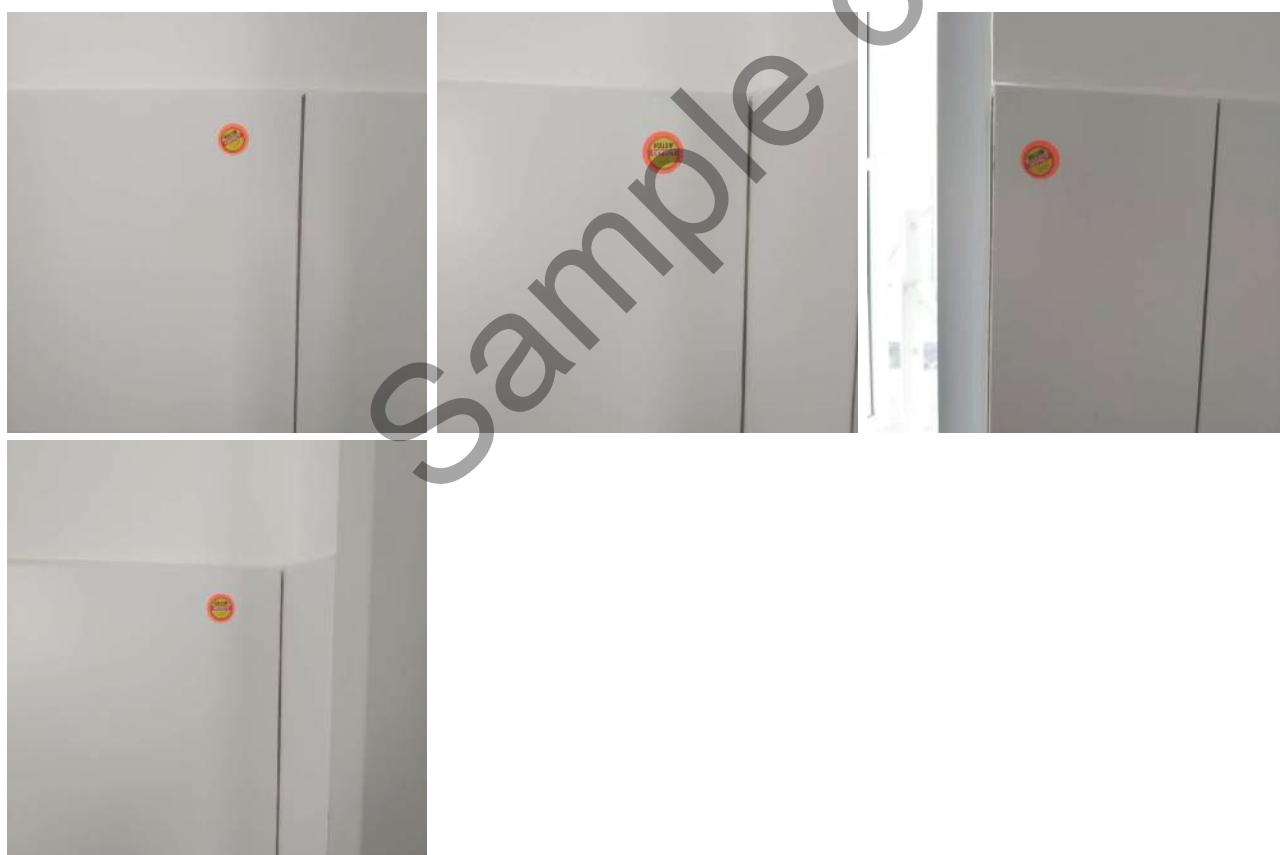
### 6.2.3 Walls

Hollow tiles are present at time of inspection. Recommend a qualified contractor re-attach and seal.

- Hollow sound

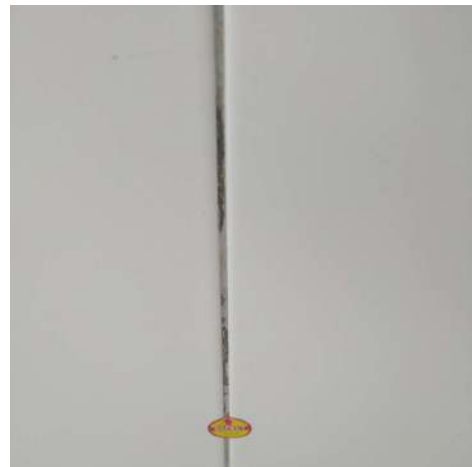
### 6.2.4 Walls

Uneven/Inconsistent grouting for the joints. Recommend a qualified contractor remove grout and regrout tile.

- Inconsistent joints

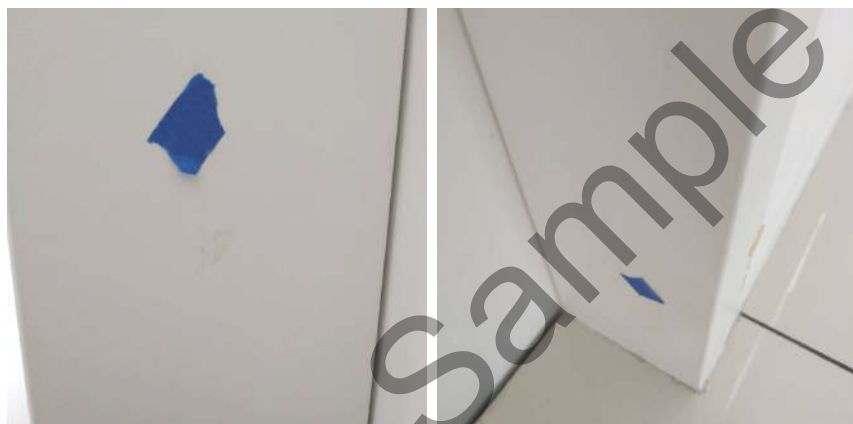
### 6.3.1 Doors

Door finish is poor. Recommend refinish and/or paint.

- Stains
- Uneven painting

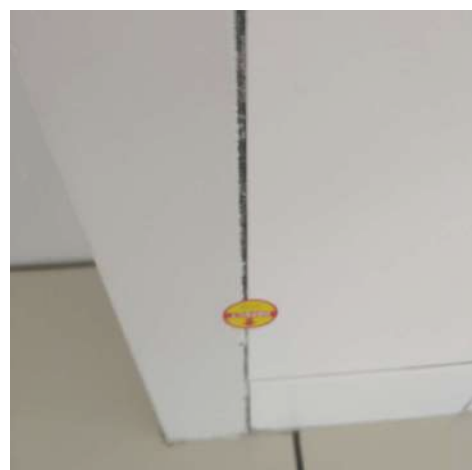
### 6.3.2 Doors

Visible gaps & inconsistent jointing found between the door frame and wall.

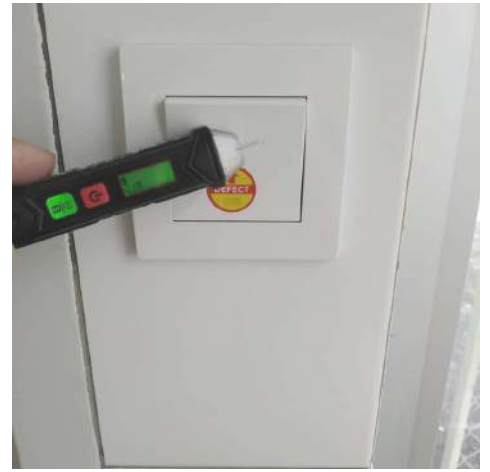
#### 6.4.1 M&E Fittings

No voltage response when using voltage detector pen. Recommend electrician check for the wiring.

- Malfunction

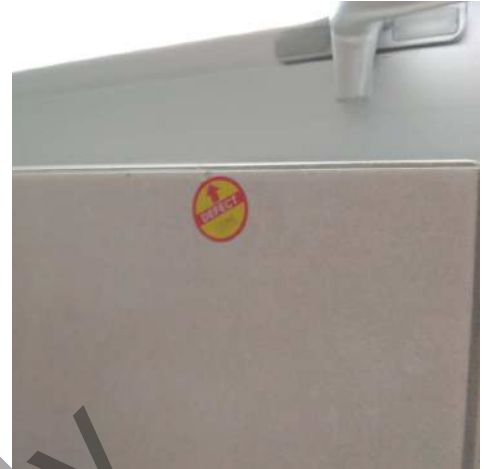
#### 7.1.1 Walls

Wall tile have severe surface damage visible at the time of the inspection. Recommend a qualified contractor evaluate & remedy.

- Chipping

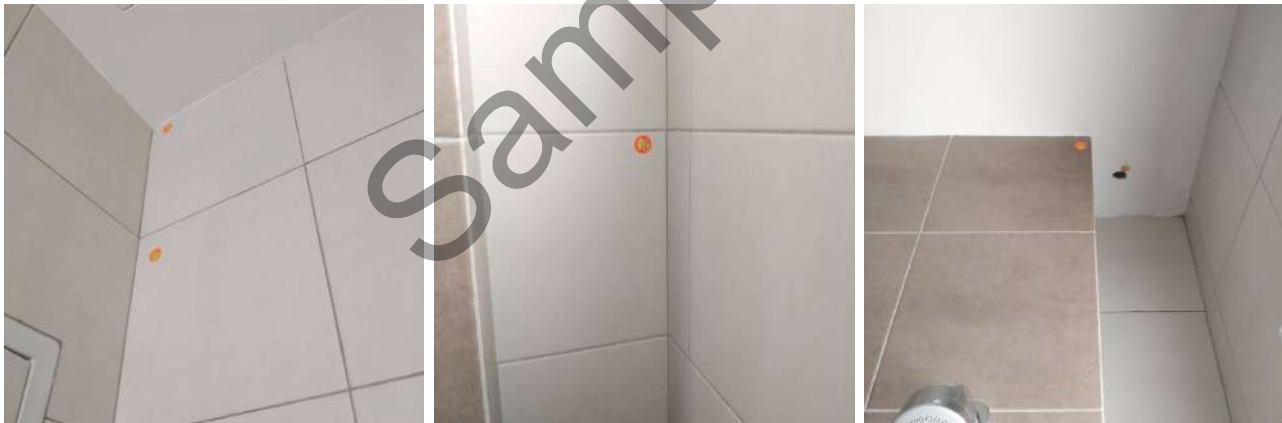
#### 7.1.2 Walls

Hollow tiles are present at time of inspection. Recommend a qualified contractor re-attach and seal.

- Hollow sound

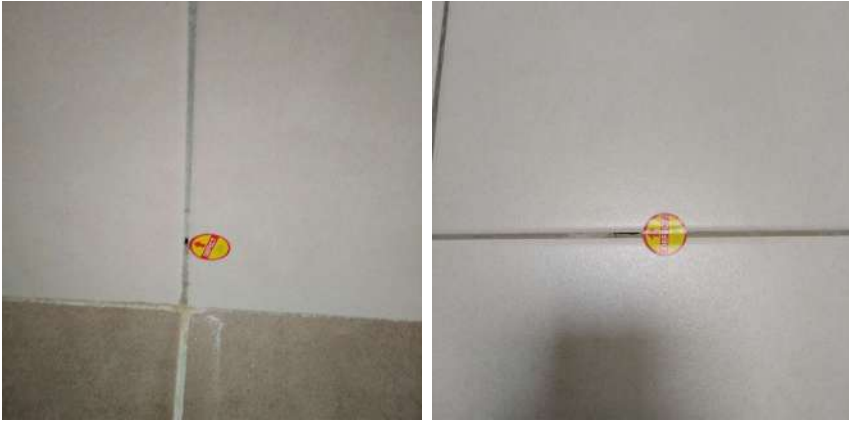
#### 7.1.3 Walls

Uneven/Inconsistent grouting for the joints. Recommend a qualified contractor remove grout and regrout tile.

- Inconsistent joints
- Visible gaps

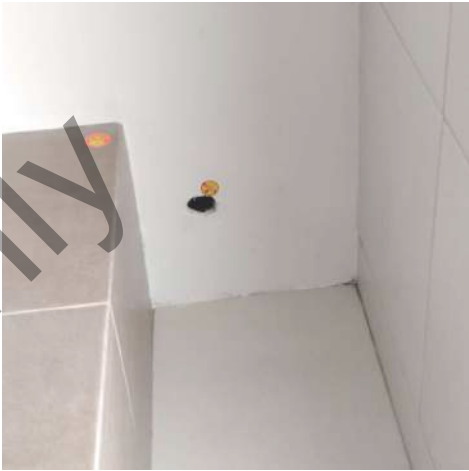
7.2.1 Ceilings

Minor damage or deterioration to the ceiling was visible at the time of the inspection.

- visible hole

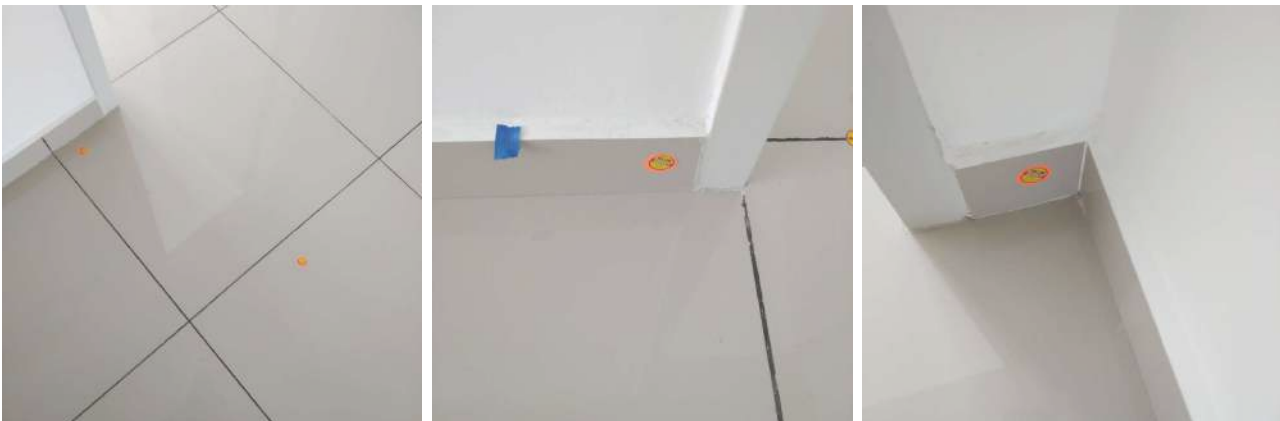
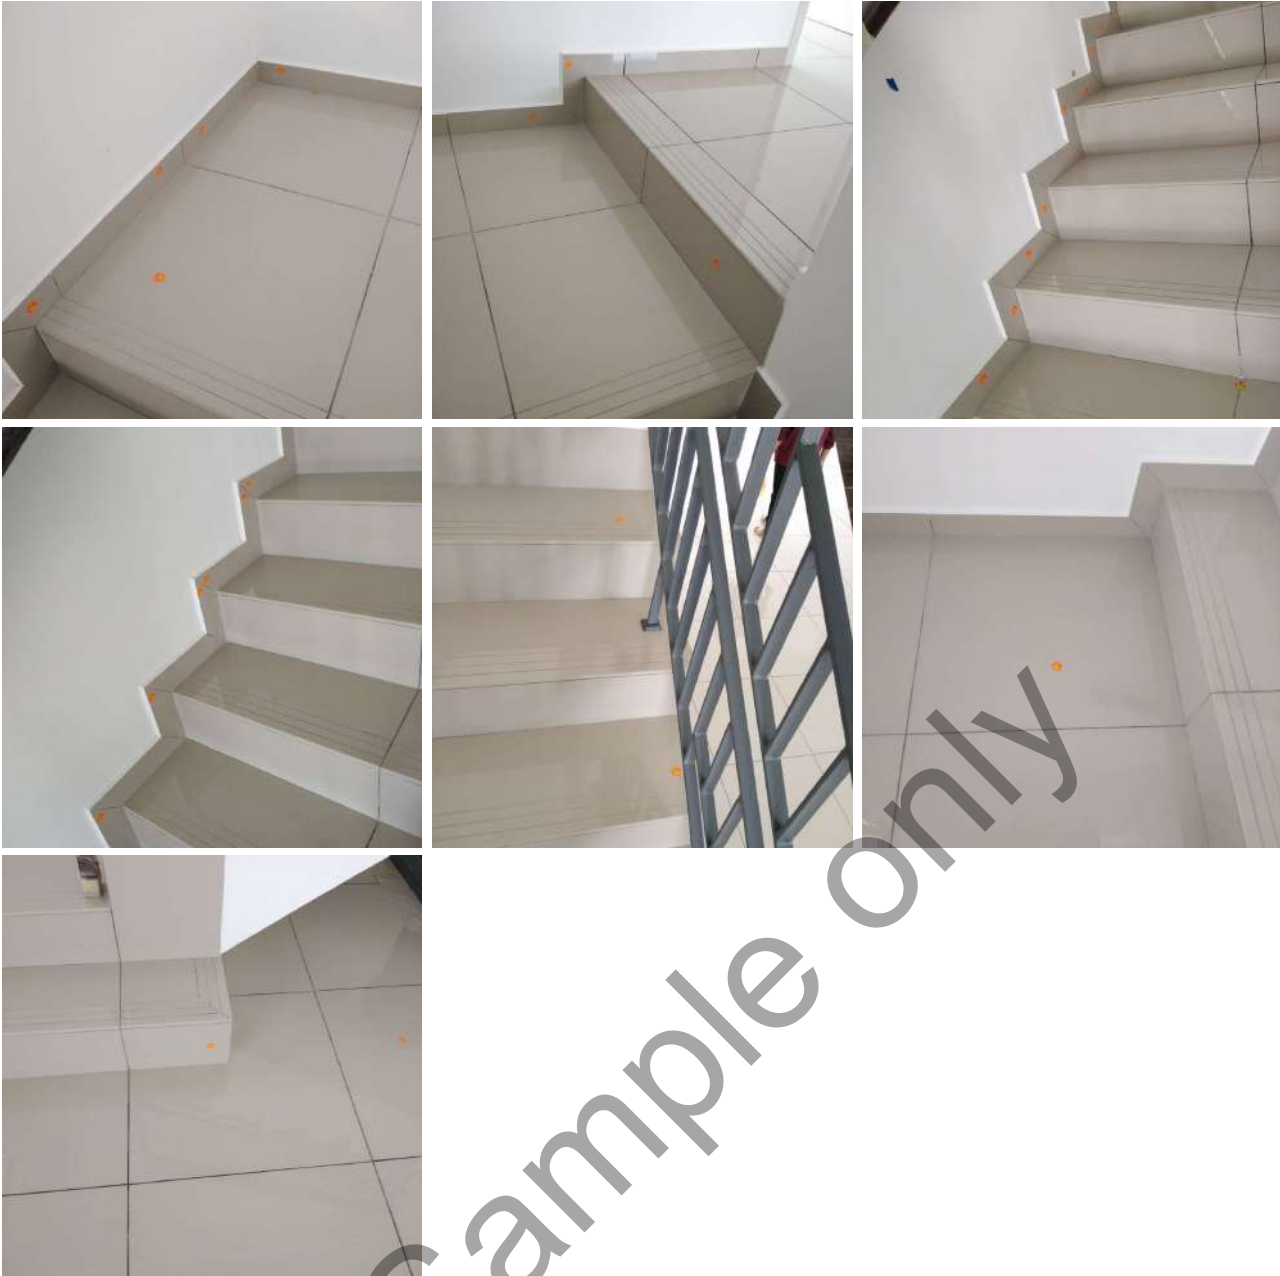
#### 8.1.2 Floors

Hollow tiles are present at time of inspection. Recommend a qualified contractor re-attach and seal.

- Hollow sound

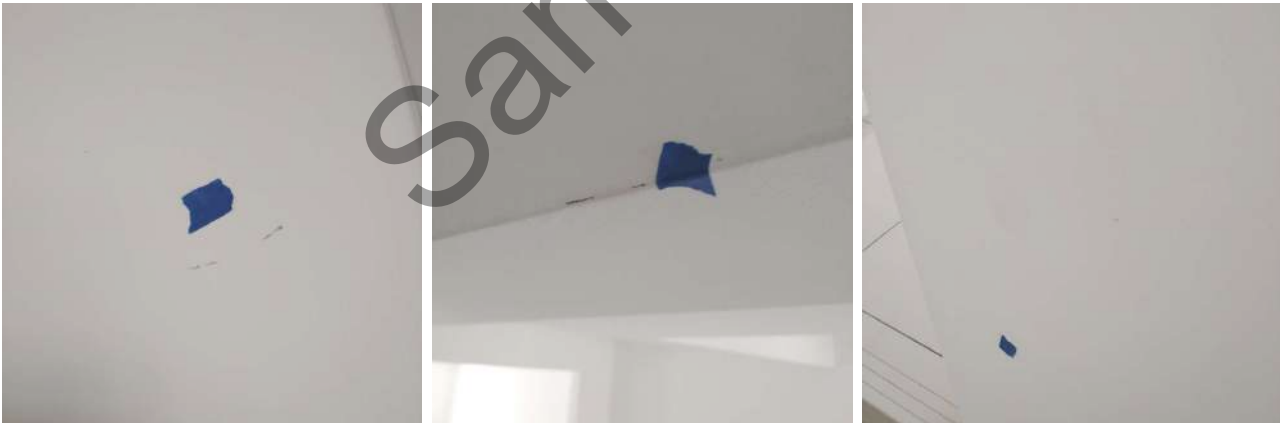
### 8.2.1 Walls

There is a stain on wall that requires repair and paint.

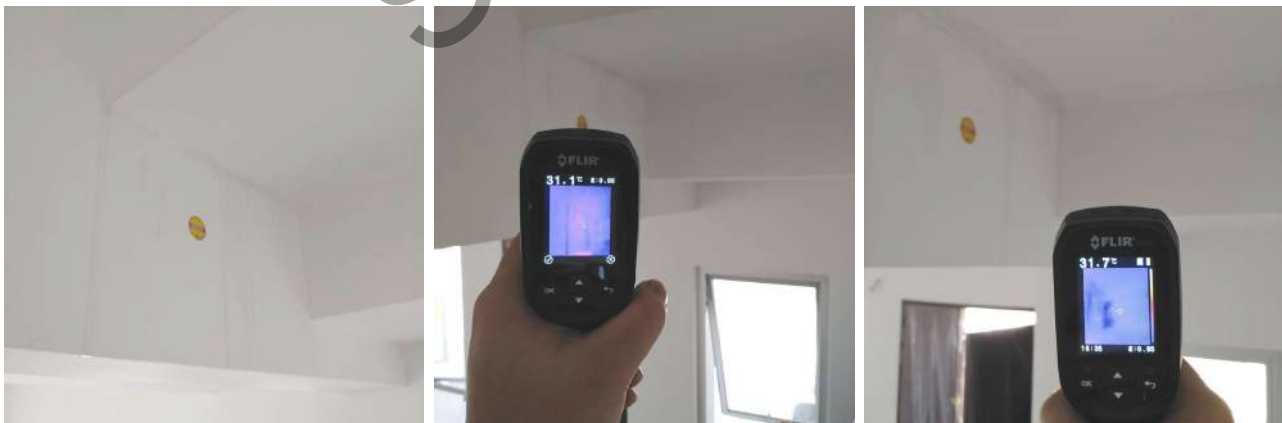
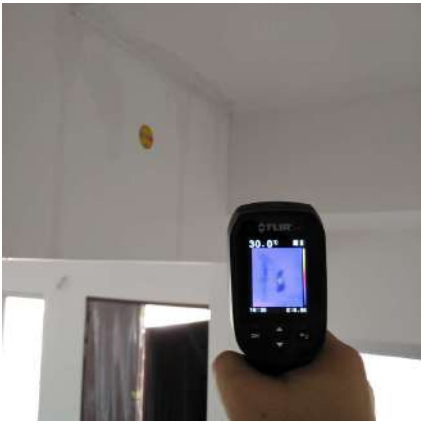
### 8.3.1 Ceilings

Stains on the ceiling appear to be the result of bathroom leaks. The source of leakage should be identified and corrected, and the ceiling re-painted.

During Water Ponding Test on bathroom's wet and dry area for water proofing floor, FLIR Thermal Imaging technology is used for scanning and found out temperature differences on dry area that indicates high possibility of water leakage.

However, the major defect was found at the staircase ceiling, it was leaking during water ponding test at bathroom 1. It should be remedy as soon as possible.

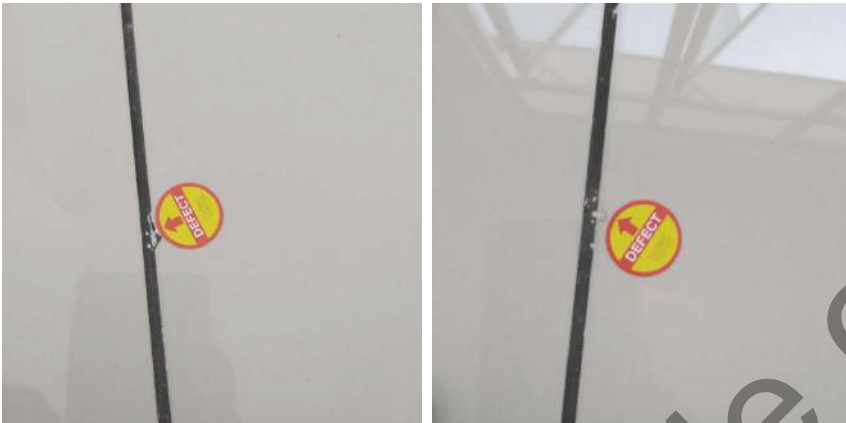
#### 9.1.1 Floors

Floors have severe surface damage visible at the time of the inspection. Recommend a qualified flooring contractor evaluate & remedy.

- Chipping

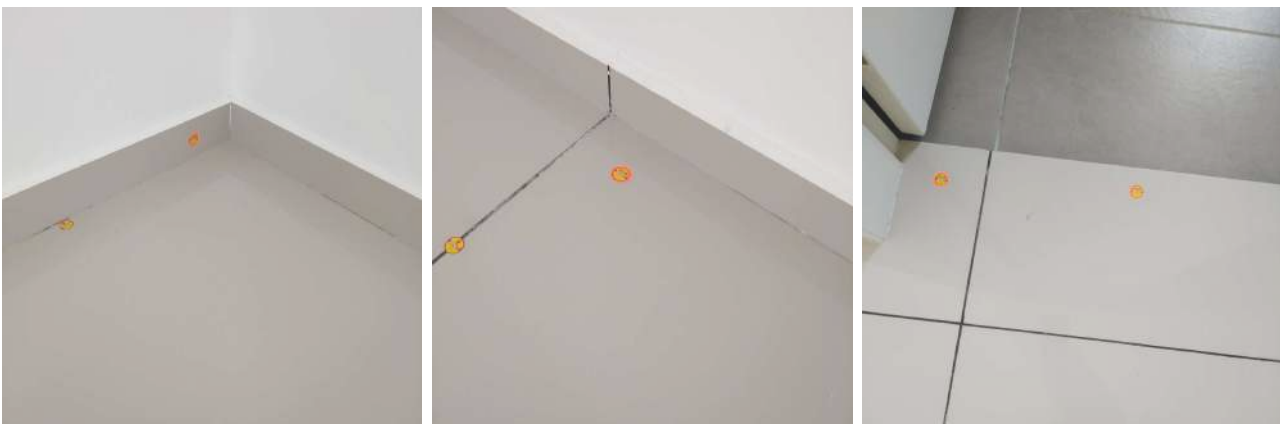
#### 9.1.2 Floors

Hollow tiles are present at time of inspection. Recommend a qualified contractor re-attach and seal.

- Hollow sound

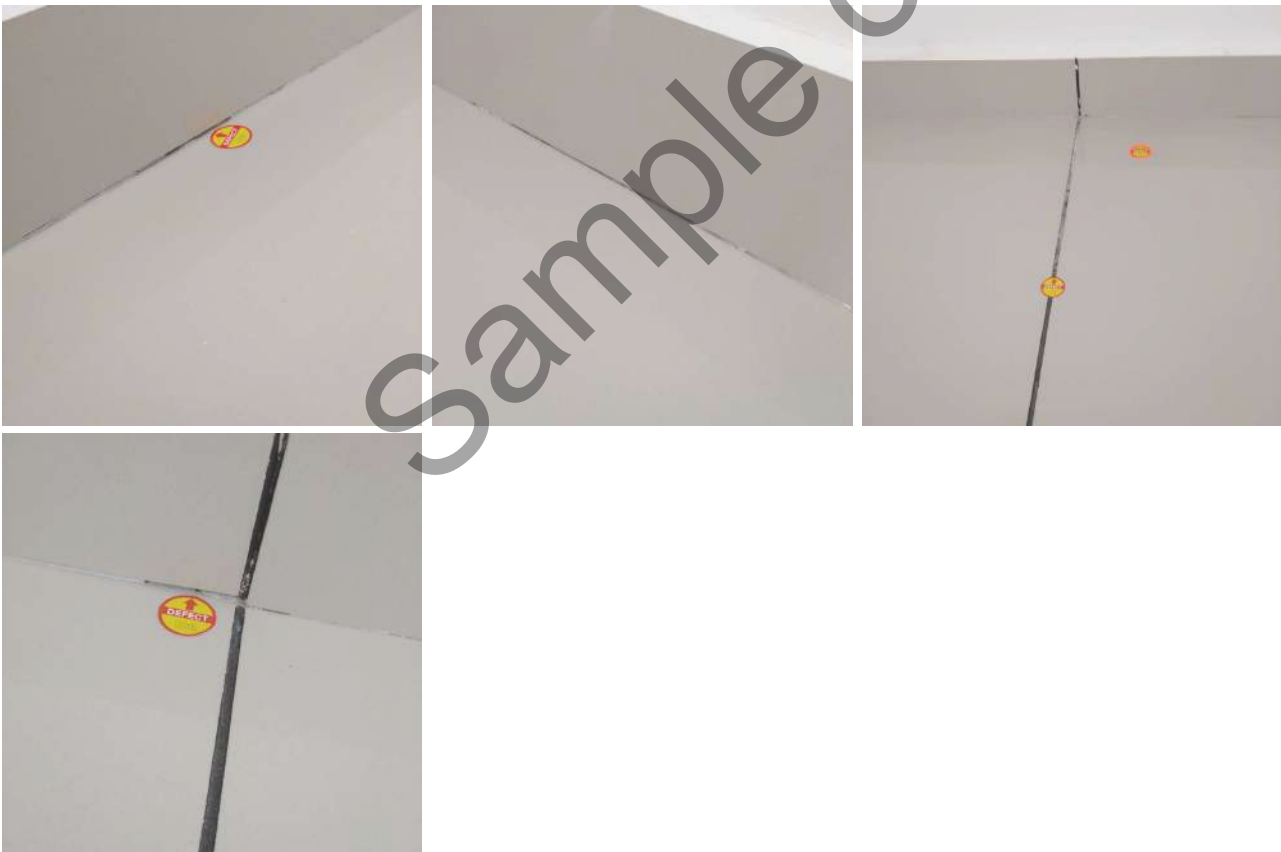
9.1.3 Floors

Uneven/Inconsistent grouting for the joints. Recommend a qualified contractor remove grout and regrout tile.

- Inconsistent joints
- visible gaps

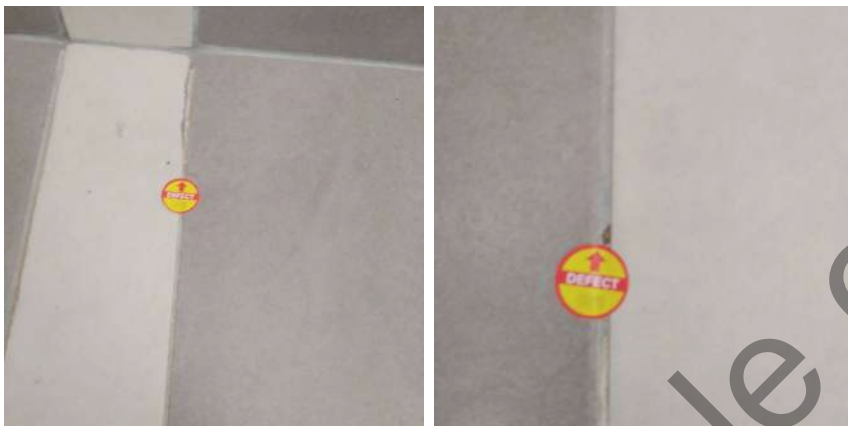
### 10.1.1 Floors

Uneven/Inconsistent grouting for the joints. Recommend a qualified contractor remove grout and regrout tile.

- Inconsistent joints
- visible gaps

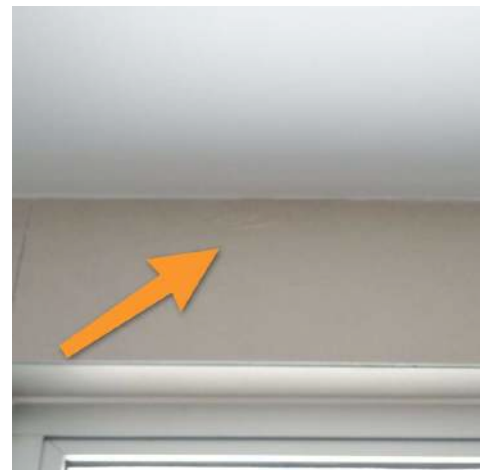
### 10.2.1 Walls

Wall tile found staining or discoloration at the time of inspection. Recommend a qualified tiler contractor evaluate & remedy.

- Stains

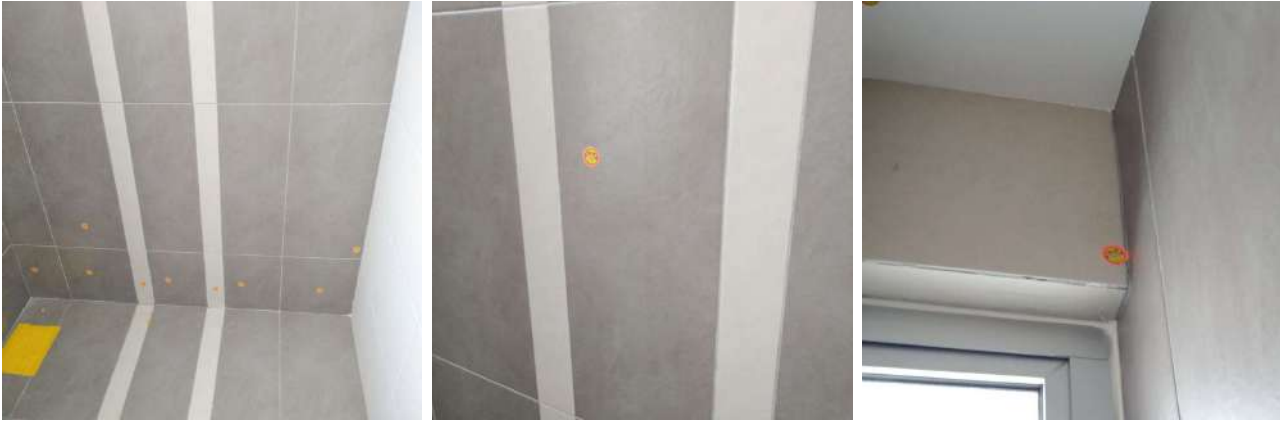
### 10.2.2 Walls

Hollow tiles are present at time of inspection. Recommend a qualified contractor re-attach and seal.

- Hollow sound

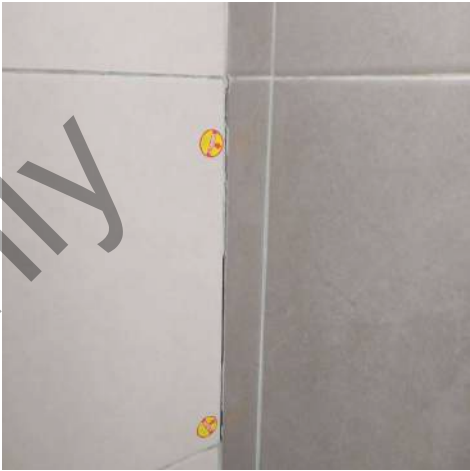
10.2.3 Walls

Uneven/Inconsistent grouting for the joints. Recommend a qualified contractor remove grout and regrout tile.

- Inconsistent joints
- Visible gaps

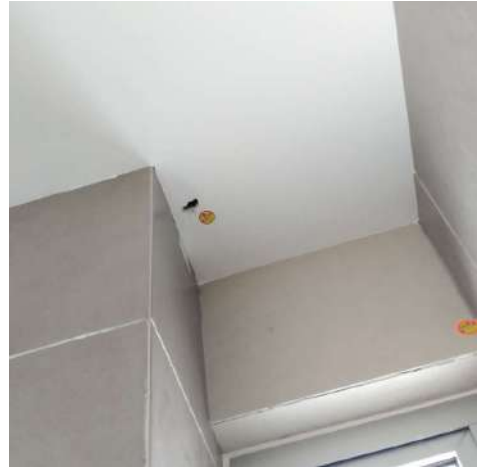
10.3.2 Ceilings

Minor damage or deterioration to the ceiling was visible at the time of the inspection.

- Visible hole

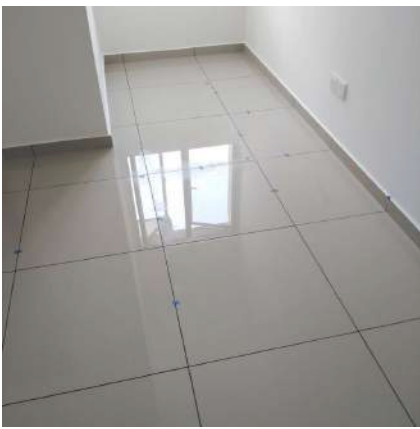
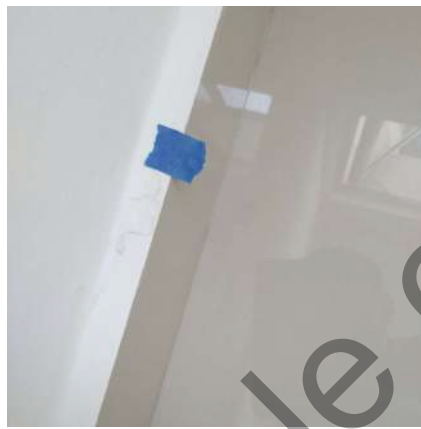
### 11.1.1 Floors

Flooring had severe surface areas of staining or discoloration. Recommend a qualified flooring contractor evaluate & remedy.

- Stains
- Tonality

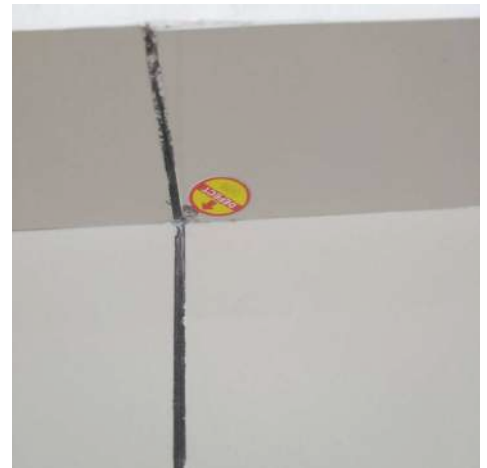
### 11.1.2 Floors

Floors have severe surface damage visible at the time of the inspection. Recommend a qualified flooring contractor evaluate & remedy.

- Chipping

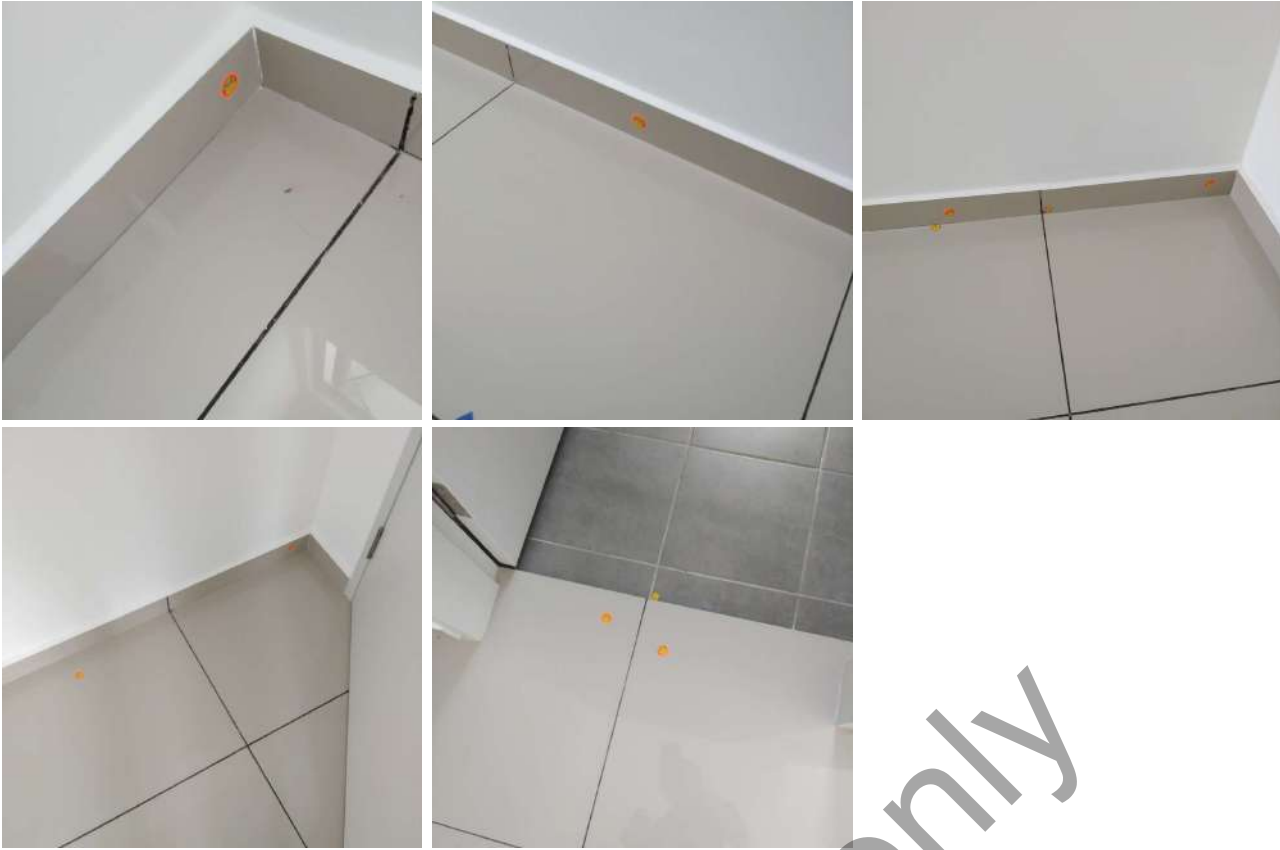
### 11.1.3 Floors

Hollow tiles are present at time of inspection. Recommend a qualified contractor re-attach and seal.

- Hollow sound

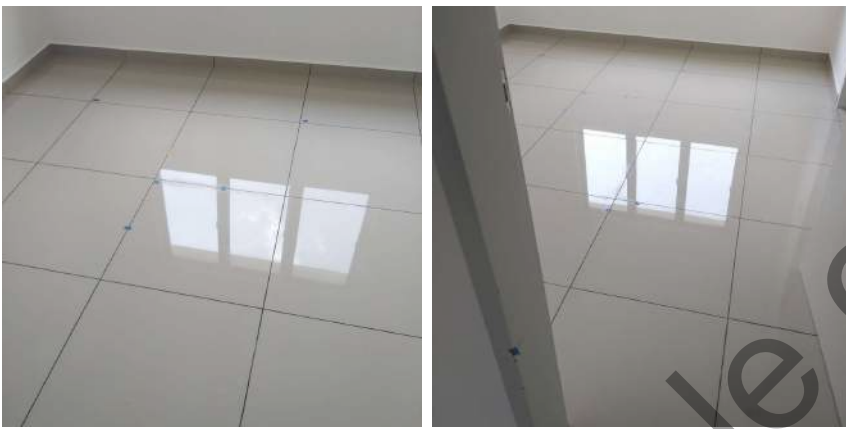
#### 12.1.1 Floors

Flooring had severe surface areas of staining or discoloration. Recommend a qualified flooring contractor evaluate & remedy.

- Stains
- Tonality

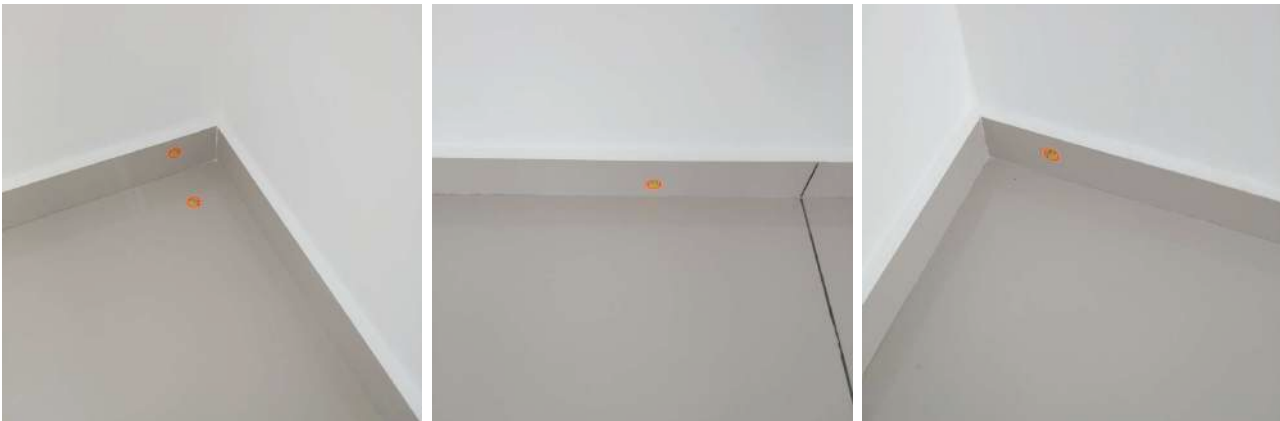
#### 12.1.2 Floors

Hollow tiles are present at time of inspection. Recommend a qualified contractor re-attach and seal.

- Hollow sound

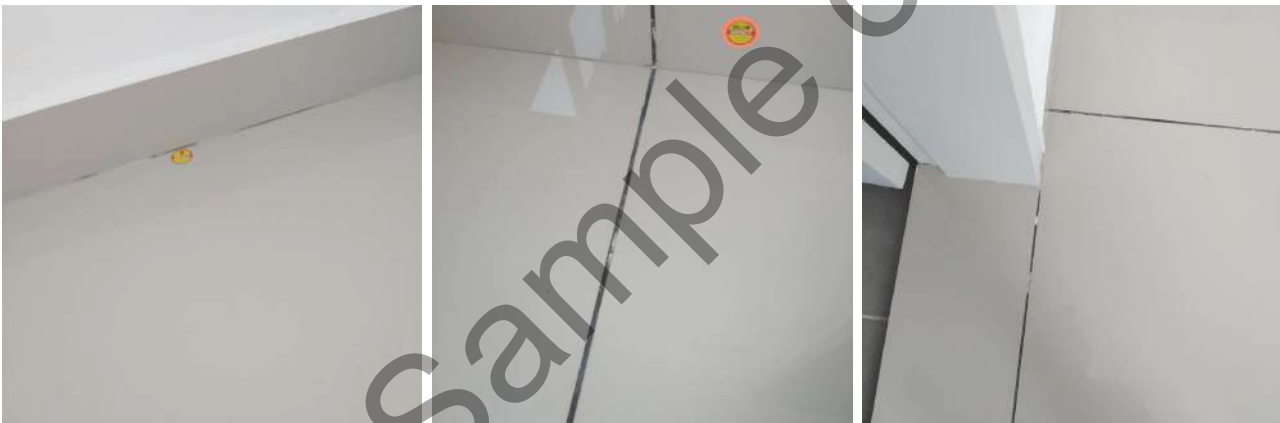
### 12.1.3 Floors

Uneven/Inconsistent grouting for the joints. Recommend a qualified contractor remove grout and regrout tile.

- Inconsistent joints
- visible gaps

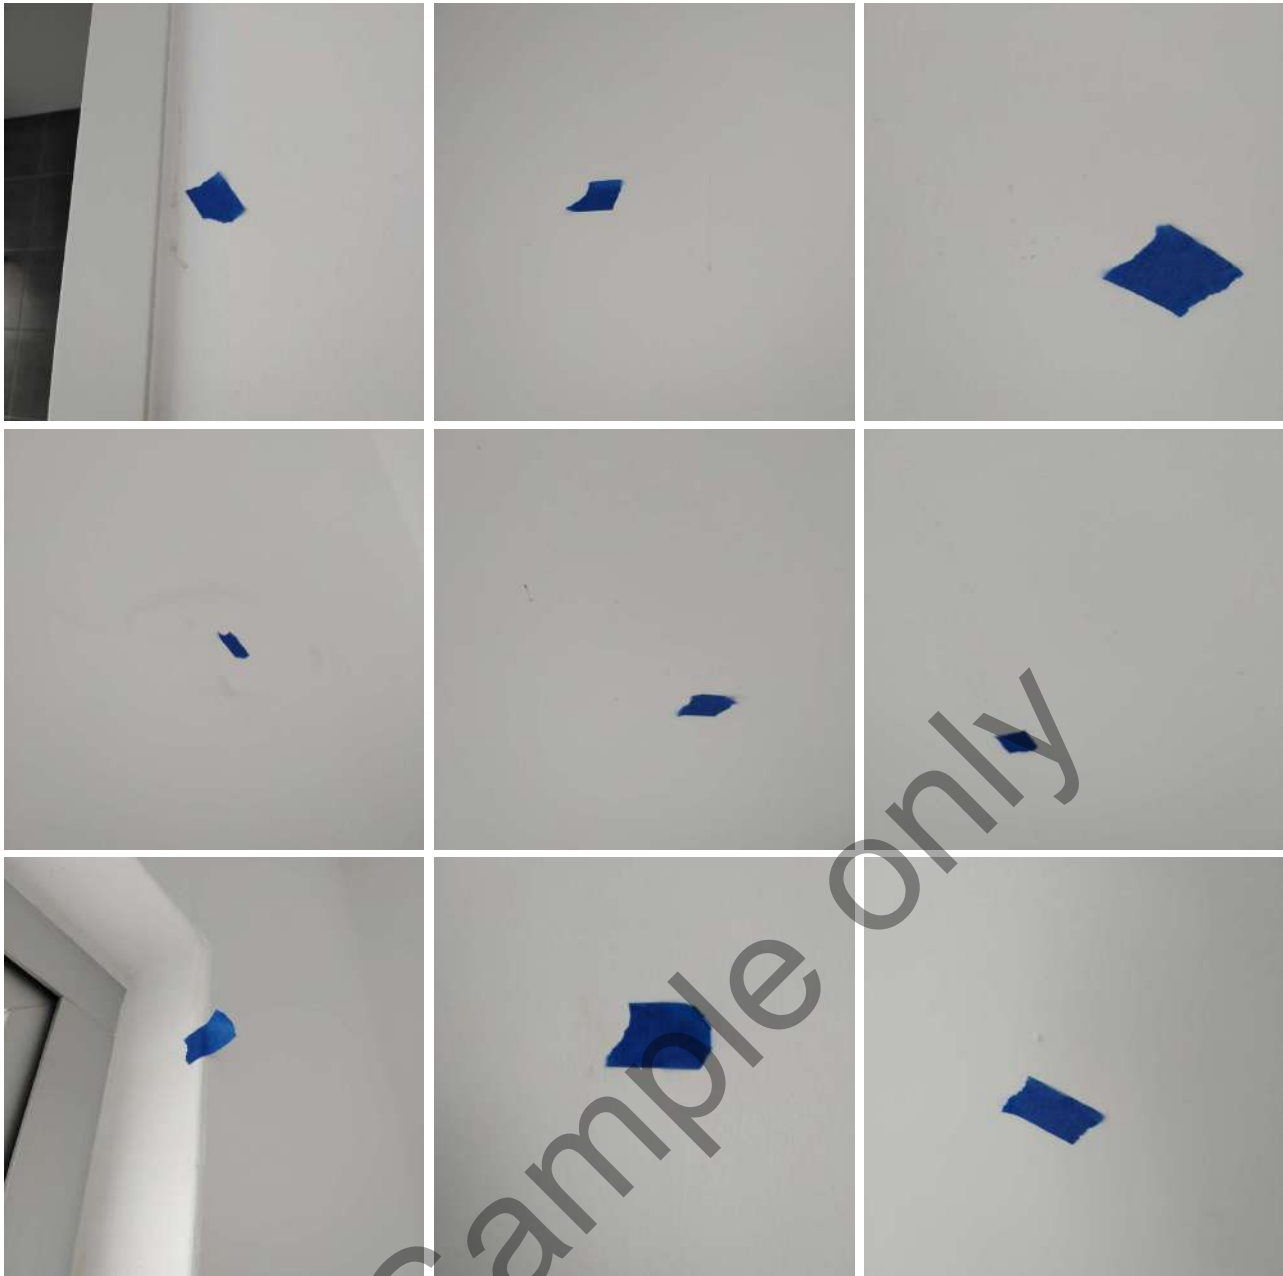
### 12.2.1 Walls

Poor Finishing for the surface of wall. Recommend a qualified painter evaluate and apply a new coat and repaint.

- Stains mark
- Rough surface

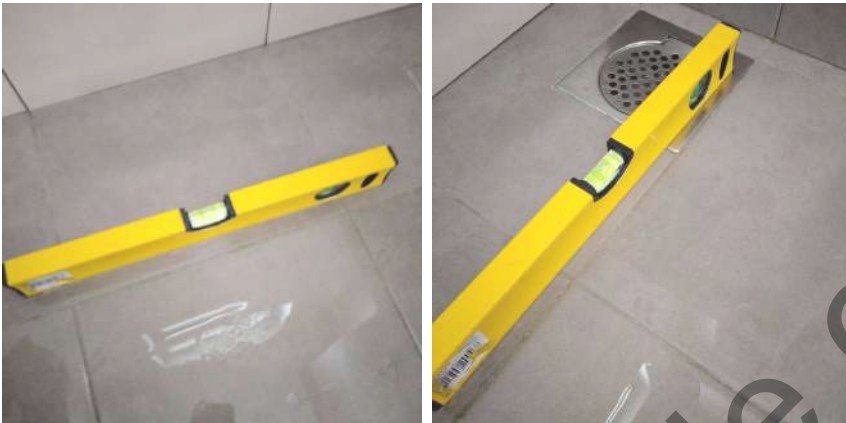
#### 13.1.1 Floors

Floors gradient for the wet areas not in right direction. Recommend a qualified flooring contractor evaluate & remedy.

- Gradient at the wet areas should be in right direction

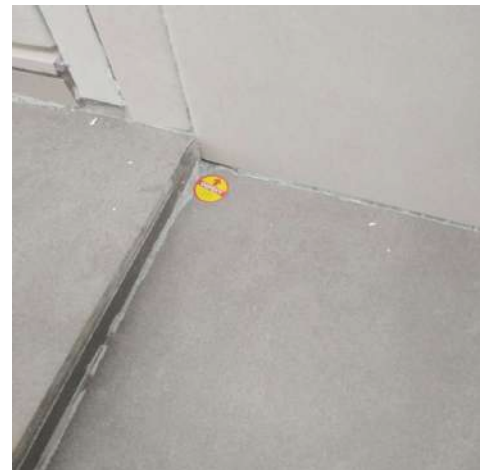
#### 13.1.2 Floors

Uneven/Inconsistent grouting for the joints. Recommend a qualified contractor remove grout and regrout tile.

- Inconsistent joints
- visible gaps

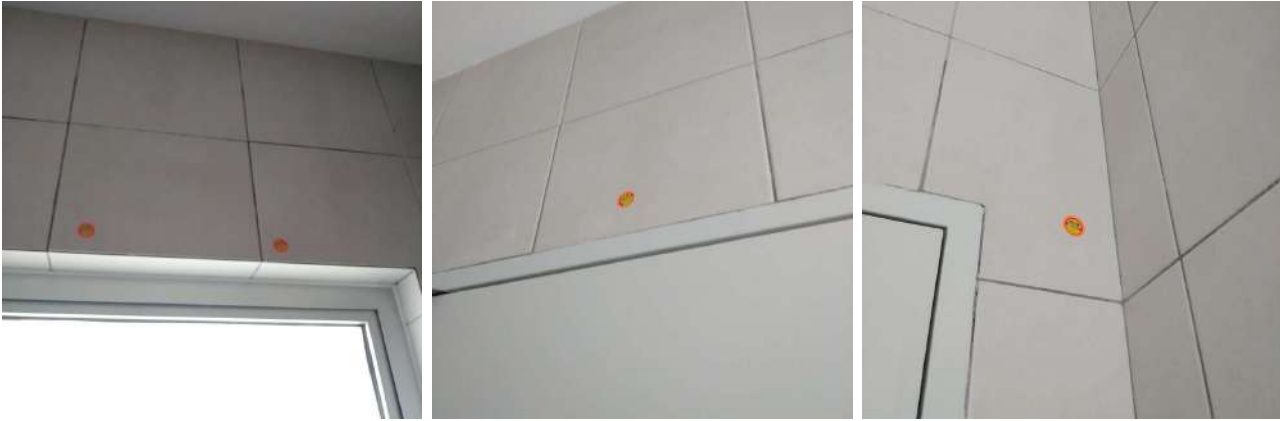
#### 13.2.1 Walls

Hollow tiles are present at time of inspection. Recommend a qualified contractor re-attach and seal.

- Hollow sound

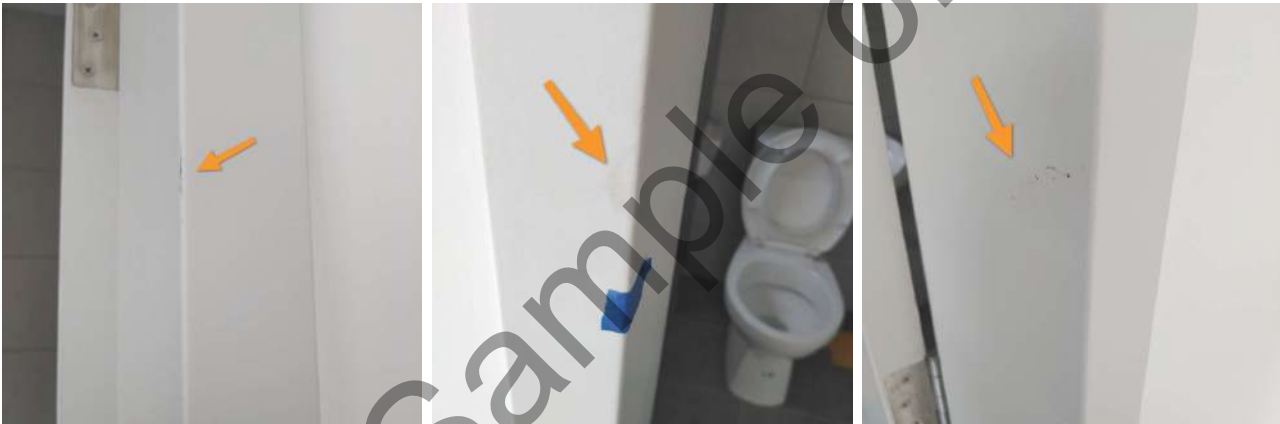
13.5.1 Door 2

Door finish is poor. Recommend refinish and/or paint.

- Stains mark
