HOME DEFECT INSPECTION REPORT  
(SAMPLE)

AUGUST 13, 2019

Newly House

Terrace

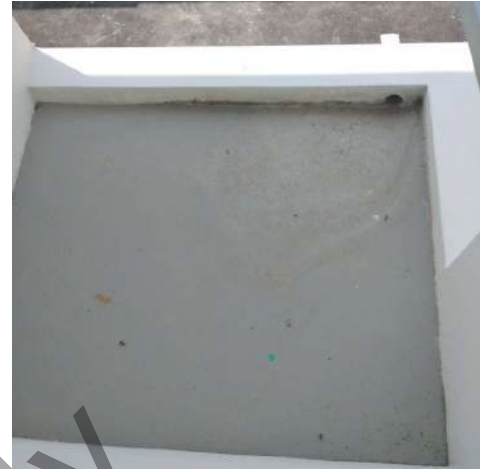
#### 14.1.1 Floors

Flooring had severe surface areas of staining or discoloration.  
Recommend a qualified flooring contractor evaluate & remedy.

- Stains
- Rough
